Public Water System Annual Report

Southwest Regional Water Treatment Plant & Southwest Regional Water Co-op
2019

Date Prepared: 3/10/2019

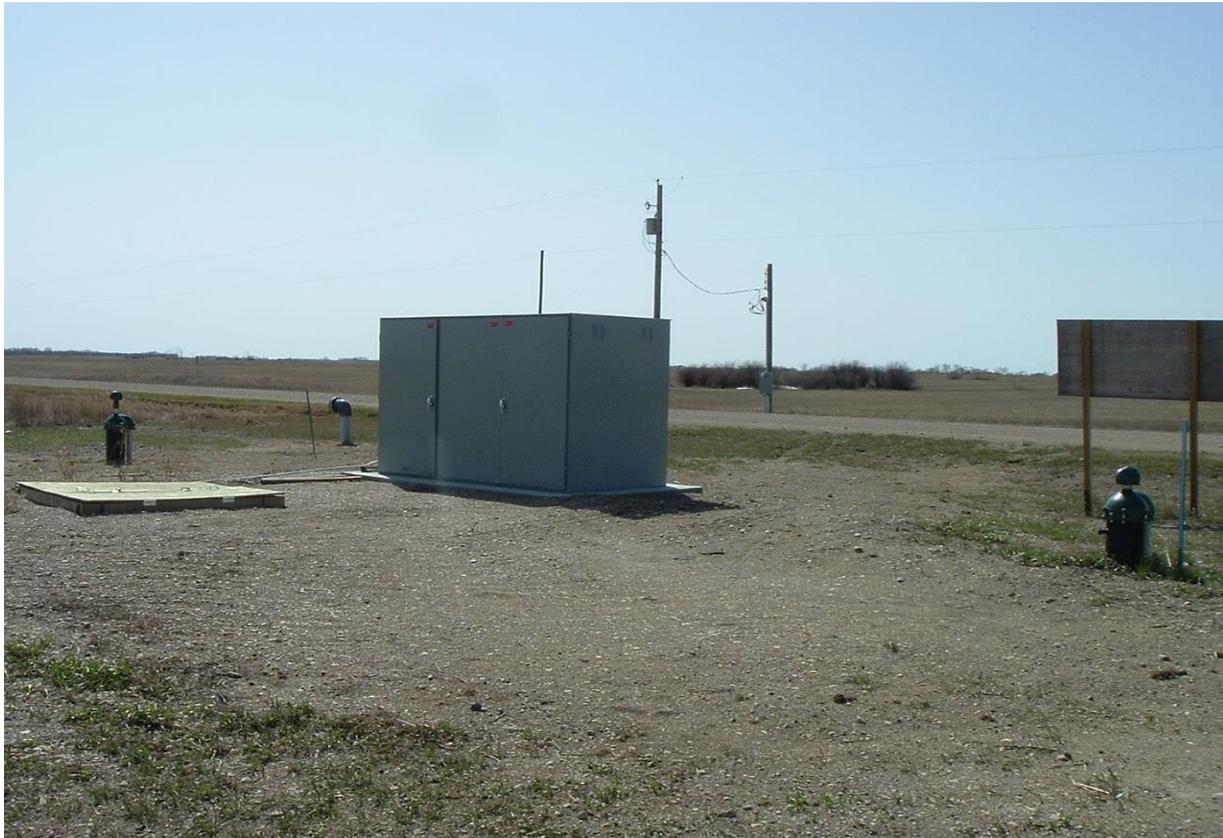
Well Site 1

The WTP receives groundwater from four wells located at 16 km North East of Melita @ NW23-5-27W. The wells draw groundwater from the Oak Lake Aquifer. The wells were drilled to a depth of 33 feet. Raw water pumped from the wells into a 200 mm (8 inch) pipeline where it flows directly into the WTP for processing and treatment.

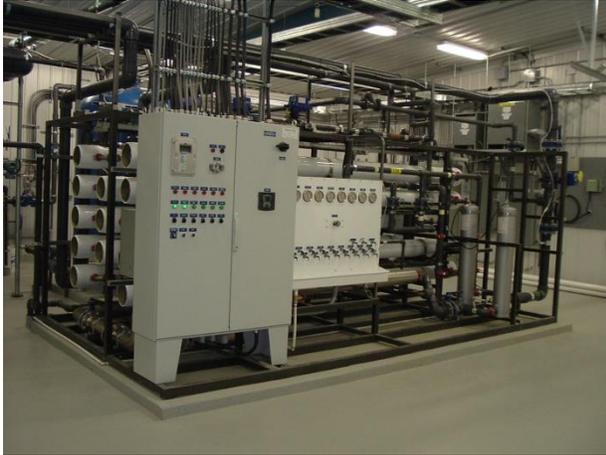
The South RO (original unit)

Raw water is pumped to the WTP where approximately 90% of the flow is directed through reverse osmosis membranes. The remaining 10% by-passes through a sand-filter with 3 new UV (ultraviolet) units prior to blending with membrane permeate. Blended flow is chlorinated with sodium hypochlorite and then stored in a 1,000,000-litre concrete reservoir for distribution. Since membranes remove most dissolved minerals, blending permeate with filter water allows the operation to produce treated water with a more desirable hardness and PH. Approximately 13% of membrane flow (11% of the raw water) is discharged as membrane concentrate to the Souris River. Treated water is distributed to the Co-op and a bulk water (truck) fill is available for rural usage. In the spring of 2014 the second RO unit and filter came online doubling the production capacity of the plant.

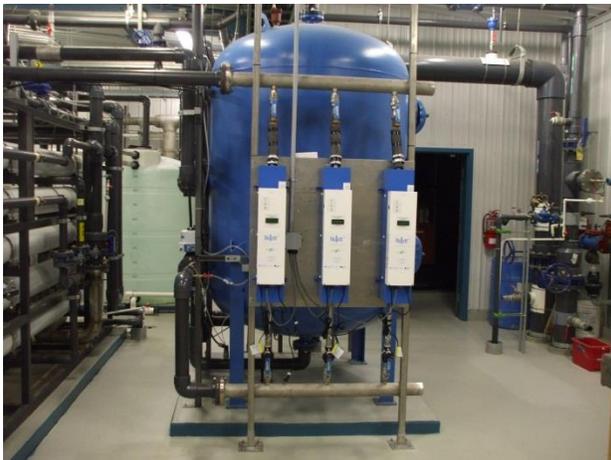
The Original Sand Filter with UV upgrade

The Melita WTP disinfects by adding a 12% sodium hypochlorite solution to the water via 4 chlorinator pumps. One for the raw water before it enters each sand-filter (pre-treatment) and two for the blended water before it enters the reservoir. In 2012 three UV units were added after the filter. In 2014 three more UV units were added after the second filter.

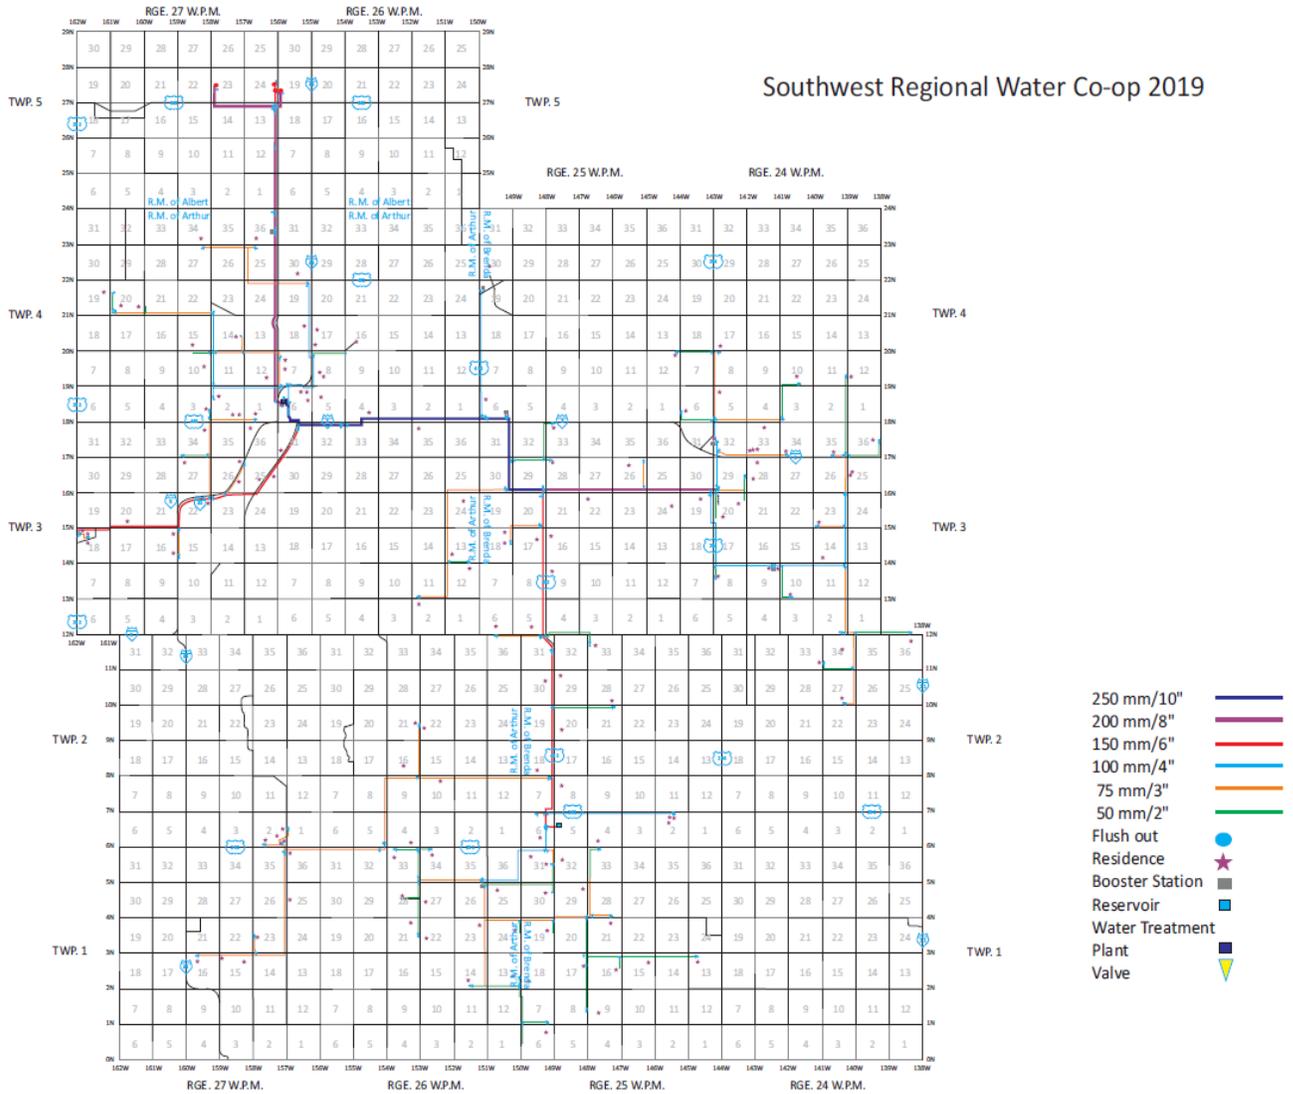
The Distribution Pumps

Treated water from the reservoir, located underneath the WTP, is pumped throughout the Melita distribution system via two 7.5 horsepower duty pumps, with one 30 horsepower emergency standby pump for firefighting purposes. The SWRWC has one 7.5 horsepower duty pump and a new 2 horsepower jockey pump which was installed in the spring of 2017. The SWRWC distribution system consists primarily of High Density Polyethylene Pipe. In 2017 the rural system was expanded to take in another 71 homes and another 150 km of pipe was installed, the raw, 10" and 8" didn't increase but the rest did. 12 miles of 8" raw water supply line, the distribution consists of the following 11 miles of 10", 5 miles of 8", 19 miles of 6", 30 miles of 4", 68 miles of 3", 49 miles of 2", for a total of 182 miles of pipe in the ground. A map of the distribution system pre-expansion is on the next page, a current map is not yet available. The Waskada Rural Water Co-op already had several miles of pipe in place but is now part of the overall distribution system. The WTP also has a natural gas powered generator located in the building that powers the distribution pumps during times of a power failure.

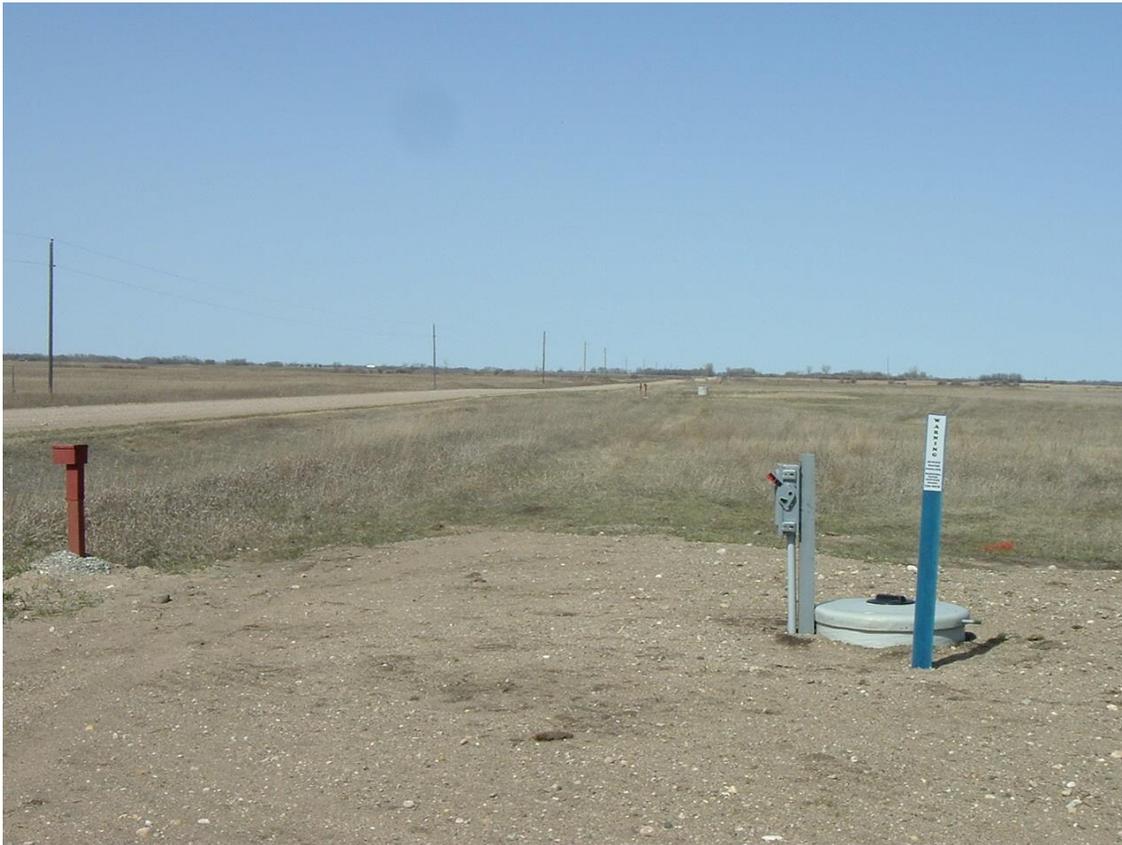
Recharge Wells

Since the middle basin could only be pumped intermittently, the north basin well was temporarily equipped with a pump, generator, and overland pipeline to speed up the water table recovery. Pumping from this basin occurred from September 3rd to September 21st until water levels significantly recovered and the north basin water table prevented further pumping. The water table in the north basin has since recovered. In 2012 the north basin was converted to a supplemental well to improve operating pressures and flows to the plant when it is in operation.

Since fall of 2017 we have not had to recharge the east site because we stopped pulling water from these wells and now only pull from the new ones at the East site.

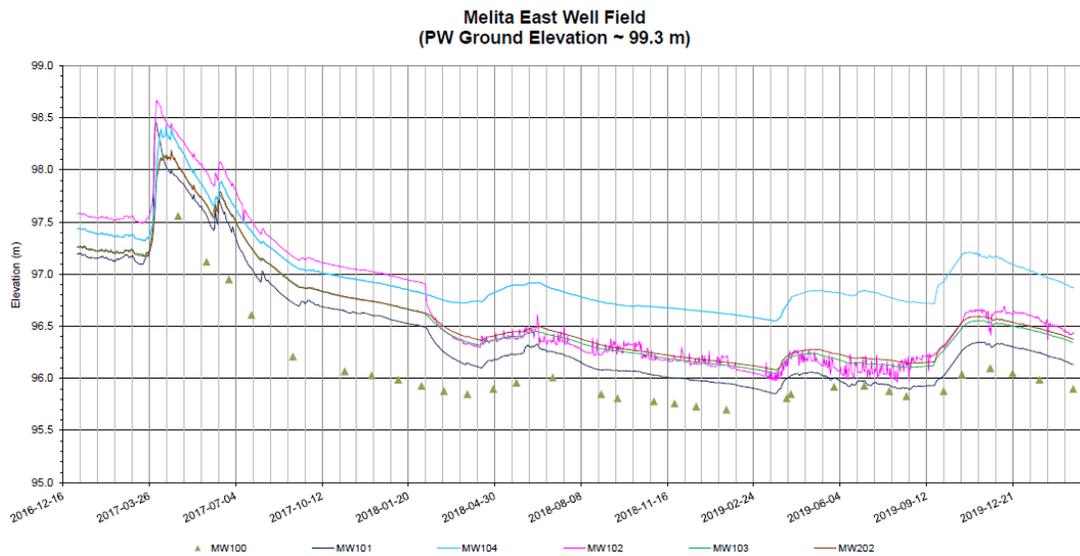
Groundwater monitoring commenced in July 2009. As many as four pressure transducers were initially set-up and currently three pressure transducers are continuous and manual readings. This graph uses a benchmark of 100.00 m in order to compare levels in each the three basins.

The locations of all monitoring wells are shown in the appendices. 5" MW represents the water table depth near the production well, while MWa and MWb represent the water table depth in the middle and north basins.

The updated graph on page 11 shows ground water levels at various points at and around the new wells.

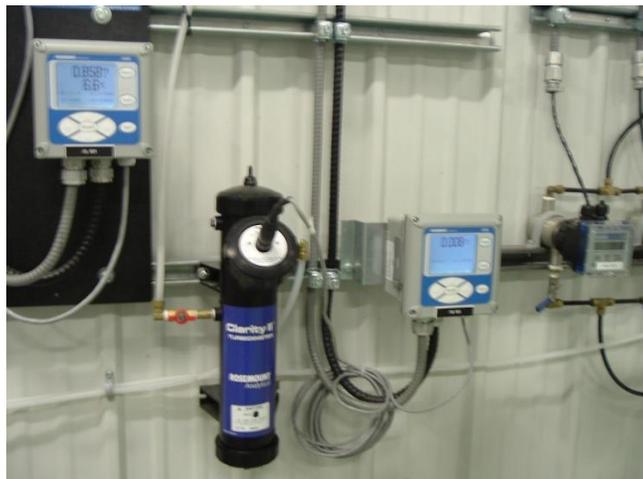
Online Monitoring Equipment

the chlorinators, as well there are two spare chlorinator pumps kept at the plant. Disinfection residuals are monitored continuously by an online monitor that monitors the water continuously as it leaves the WTP. We also monitor the residuals daily at the WTP and in the distribution system; these tests are performed at the WTP after the samples are collected. The results of all tests are recorded on our records at the WTP as well as Monthly Chlorination Report forms which are sent to the regional *Drinking Water Officer* at the end of each month, to check for standard compliance.

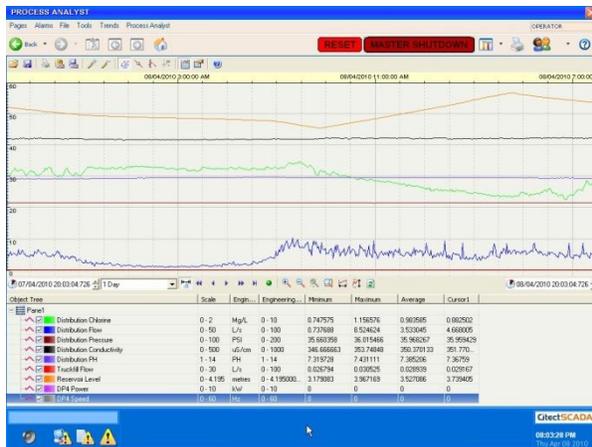
The WTP is monitored continuously by the computer system; it is continuously taking readings from 85 different locations by sensors, probes, and meters. This information is displayed in real-time on a different number of screens (*see Figure A, B, C which show three different computer screens*) and is also recorded and compiled in the form of a trend. These trends can be accessed at any time and show a history of plant operation in various areas (*see Figure D for an example of a trend screen*).
